Manhole Inspection Summary

Manhole # S23II_030MH

Insp Date: **9/29/07 10:49 AM**

Location Address: **2302 DIVISION ST**

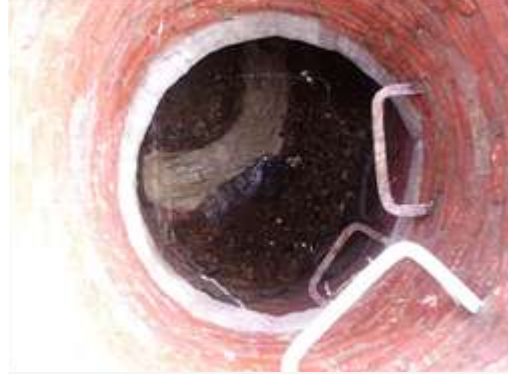
Top View

Corroded steps. Evidence of surcharge - Bench debris. Channel debris.

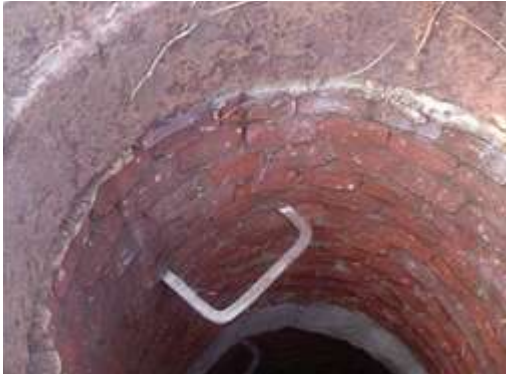
Defect

Frame leaks. Adjustment deterioration and infiltration. Corbel infiltration - other side.

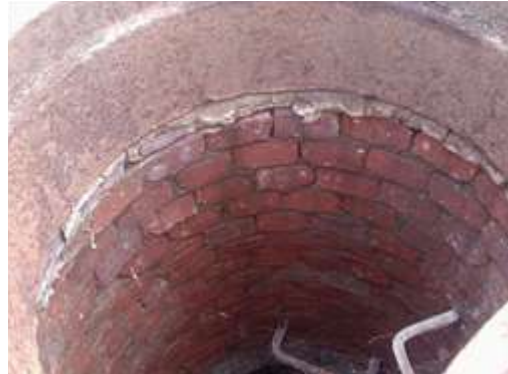
Defect

Adjustment deterioration and infiltration. Corbel infiltration.

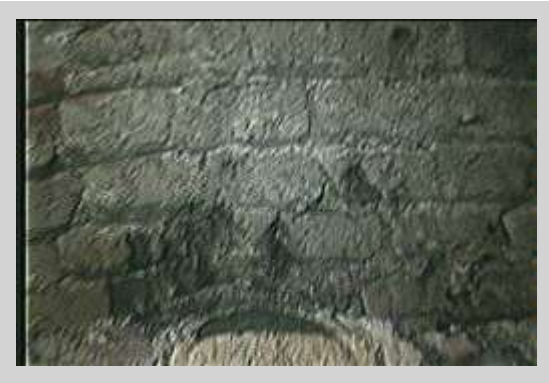
Pipe Out @ 12 O'Clock

Barrel deterioration and infiltration.

Deposits: ☐ None ☒ **Mud** ☐ Sludge ☒ **Debris** ☒ **Grease**

Silt Depth: **7** (in.) Deposits Extent: **Heavy**

Infiltration: **Evidence** Pipe Seal Cond: **Broken**

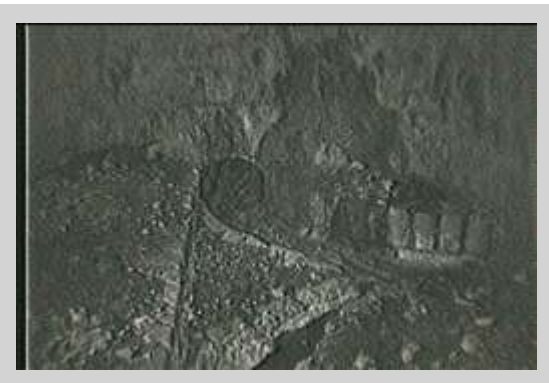
Pipe In @ 9 O'Clock

Barrel infiltration.

Deposits: ☐ None ☒ **Mud** ☐ Sludge ☒ **Debris** ☒ **Grease**

Silt Depth: **5** (in.) Deposits Extent: **Heavy**

Infiltration: **Evidence** Pipe Seal Cond: **Unknown**
